Power Plant Heated Water Line

Calgary, AB Canada

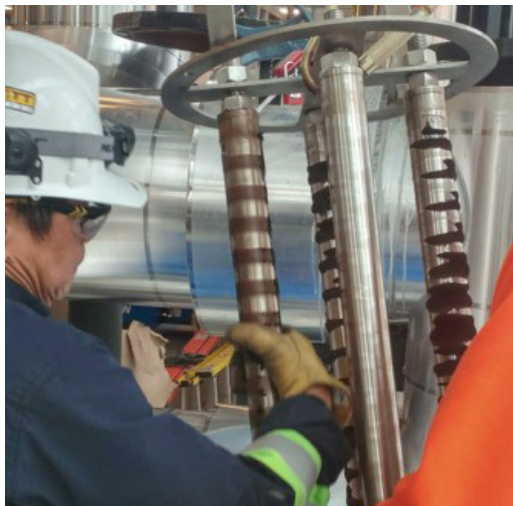
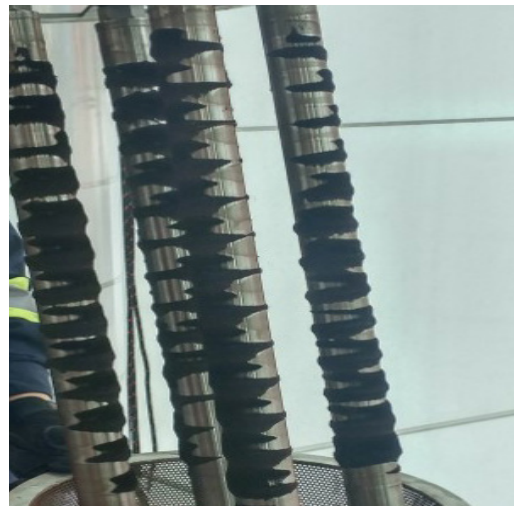
Contamination shown in the pictures was collected after 3 months of operation. Now the unit has been installed for 1.5 years, and the customer is looking to install BPS magnetic separator systems on their glycol systems and heat exchangers.

Conventional basket strainer filtration was unable to remove corrosion contamination from a heated water line.

Install magnetic separator elements into existing basket strainer as a proof of concept.
