Black Powder in Natural Gas Systems

December 2020

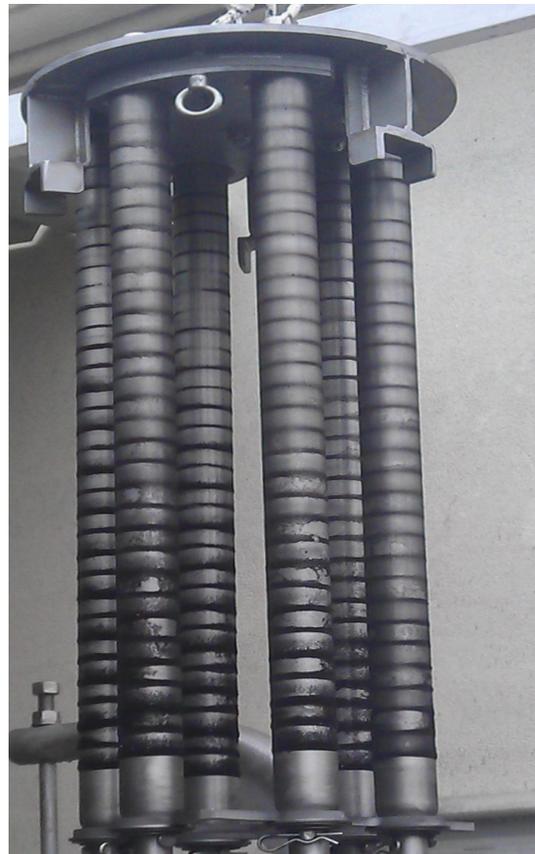
Figure 1. The magnetic array with black powder contamination on it after the array was removed for an initial inspection.

After numerous complaints by the industrial gas customer, the gas distribution utility commenced evaluating alternatives for eliminating the black powder issue. The utility ultimately decided that magnetic separation offered the best alternatives for eliminating all of the black powder as well as the costly replacement of single use filters. The Black Powder Solutions magnetic separator system was installed in 2014 and continues to operate with the same high efficiency level. Figure 1 shows the magnetic array with black powder contamination on it after the array was removed for an initial inspection.

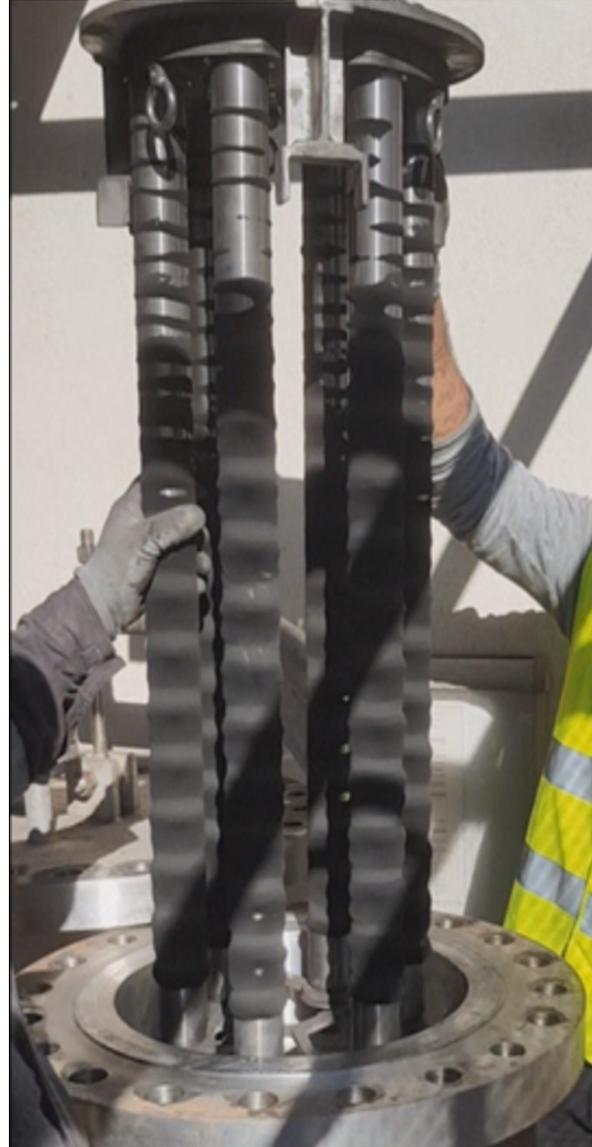
Figure 2. Removing the magnetic array from the magnetic separator during the manual cleaning process.

As shown in Figure 2 from 2018, the magnetic array is being removed from the magnetic separator housing to be cleaned and then re-installed for use. As of late 2020, the utility confirmed that the magnetic separator system continues to operate with the same high efficiency as it did in 2014.

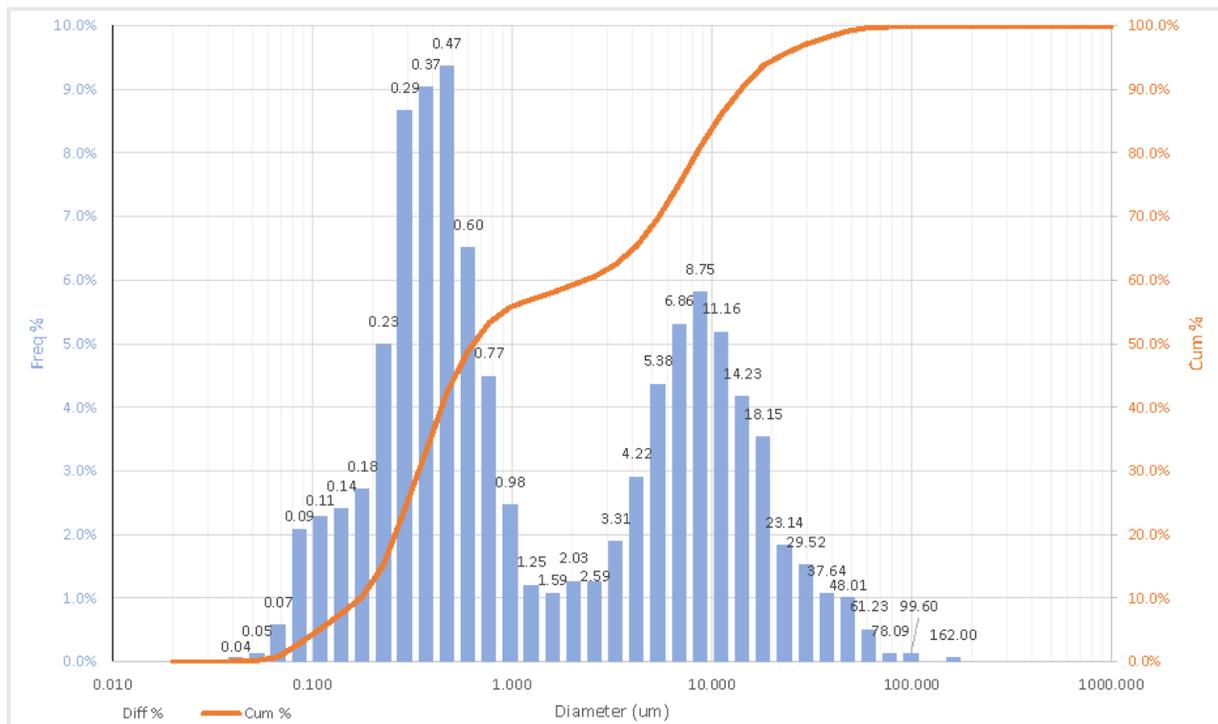
Figure 4. Histogram that illustrates particle size distribution.
