# LPG Slip Stream Test

Gulf Coast Refinery, USA / 2016

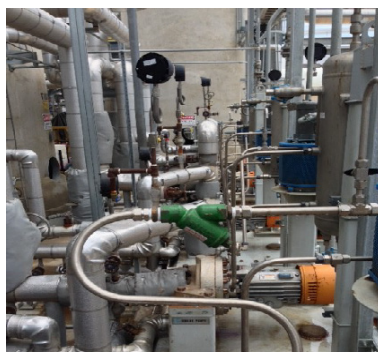
Magnetic Separator Location

A BPS magnetic separator was installed on a slip stream downstream of the cracking tower, and downstream of traditional filters to compare filtration efficiencies.

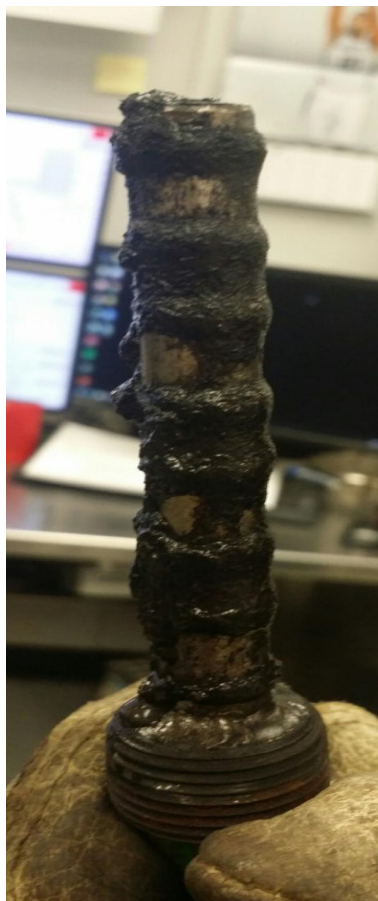
The test was successful; the magnetic separator element captured significant amounts of ferrous and non-ferrous contamination missed by the conventional filters.

Contamination collected after 10 days

Test Data	
BPS Magnetic Separator	1" OD x 3 1/2" L
Slip Stream Size	1/2"
Slip Stream Flow Rate	5 gph
Temperature	145° F
Test Duration	14 days
Black Powder Collected	18 g
Sample Size	958 g
Particulate Size	1-100 microns
Particulate Composition	50.5% Iron 23% Iron Sulphate 21.5 Sulfur 5% Magnesium, Calcium, Silica, and Aluminum.
